## Consequences of flexible power plant operation

## Damage event: boiler recirculation pump

## Failure investigation of a damaged pump

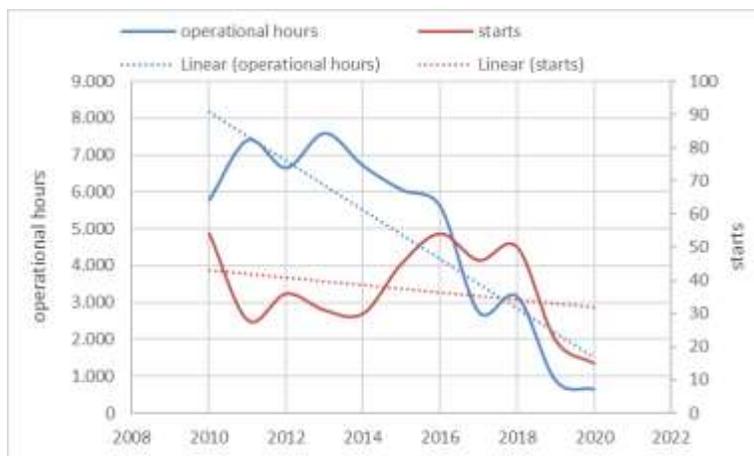
Plant A North of Germany

- Number of starts in correlation to the operational hour is increasing → more flexible operation
- Operational hours clearly decreasing in the last decade at all locations → less creep exposure
- Number of starts very dependent on plant location → partly higher exposure
- Lifetime consumption due to cyclic exposure becomes more dominant at some locations
- Lifetime consumption at lots of the locations is not significantly influenced due to reduced operation

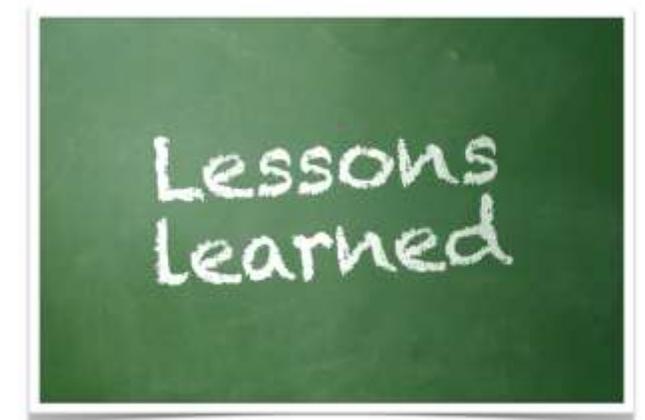
- Consequences are very plant depended and can differ
- For many plants no negative effect on the “yearly” lifetime consumption expected
  - Expected to reach year 2035 without “flexibility” damage
- Longer periods of non-operation → preservation concepts
- Cycling → Generally more complicated lifetime monitoring
  - Different inspection methods
  - Water Chemistry OT/AVT mode
- Some plant are more affected by cycling
- Up to now no significant increase in damages due to cyclic operation observed
  - However some specific failure occurred

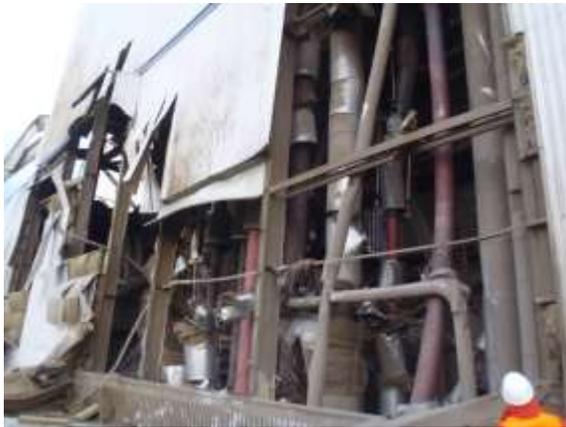
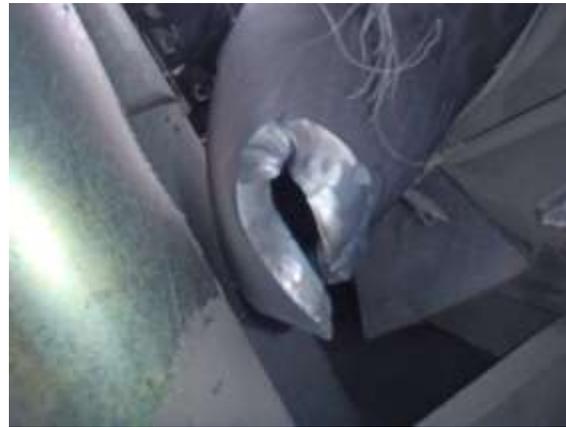
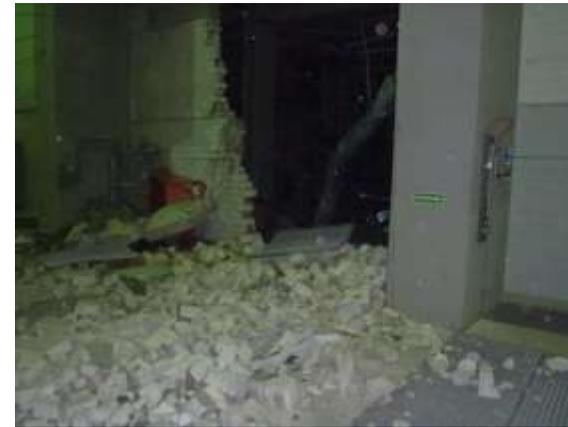
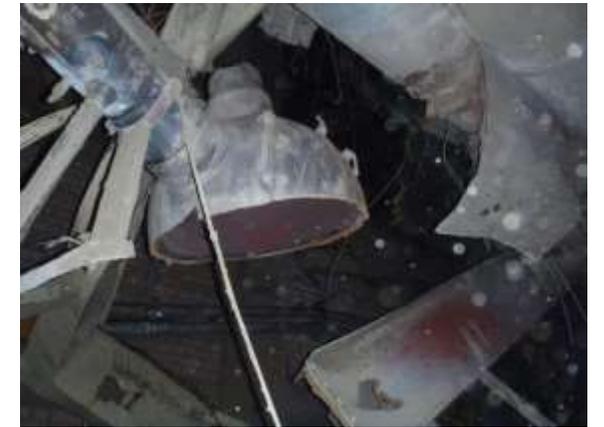
- Failure of recirculation pump led to massive damage in one plant
- Operational hours of the plant approx. 170,000 hours
- Approx. 1400 starts/stops
- Pump was inspected with conventional UT two years before
- Identification of root cause to be carried out

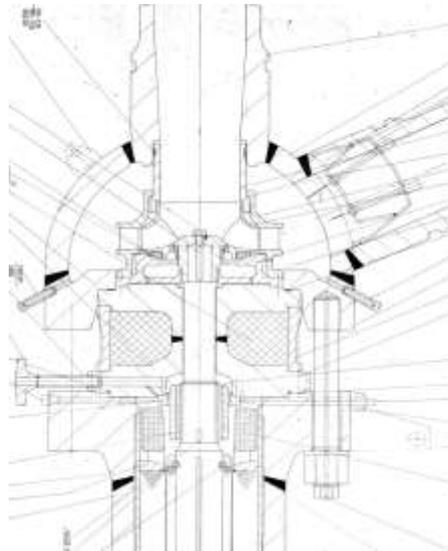
- Design of the pump not optimized for cycling operation
- 20 years of operation and changed operational regime led to damage
- Stresses are concentrated in the notch
- Many pumps with similar design were investigated

Overview drawing

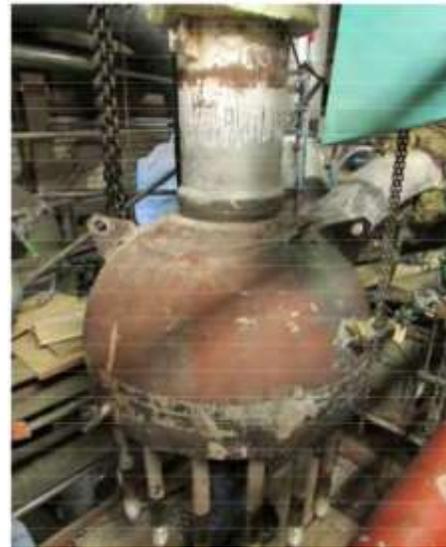
Overview picture

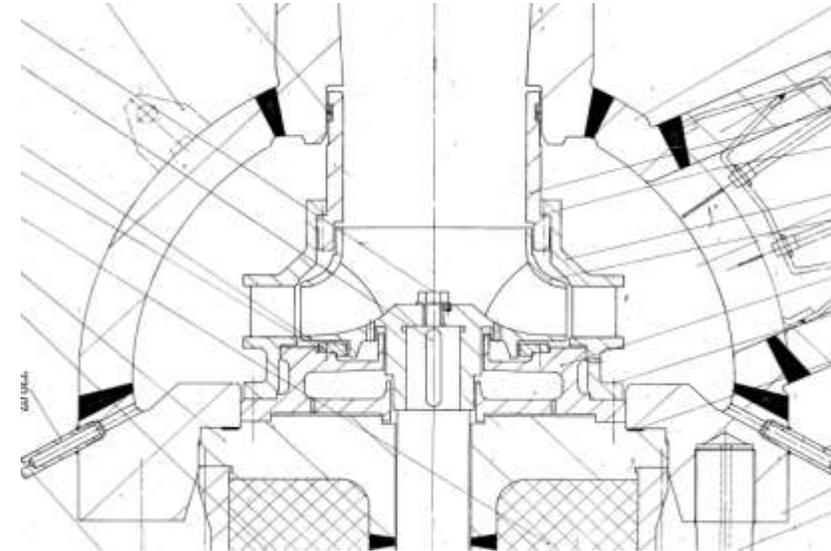
Detailed drawing of the casing

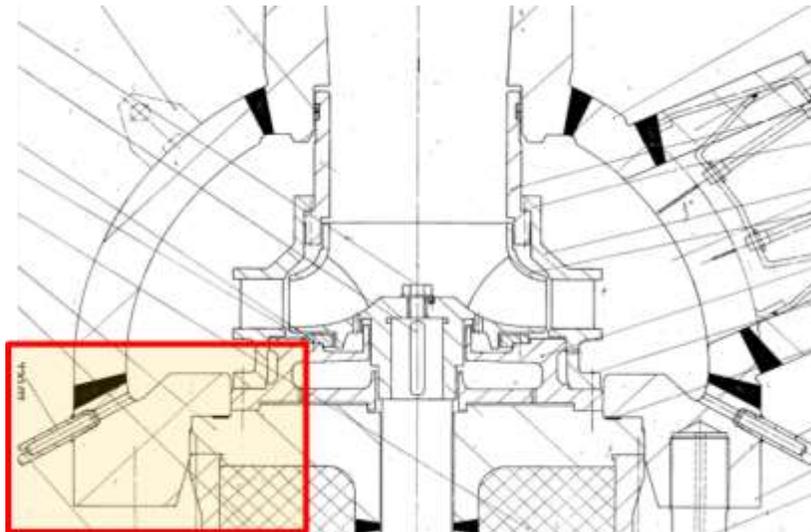
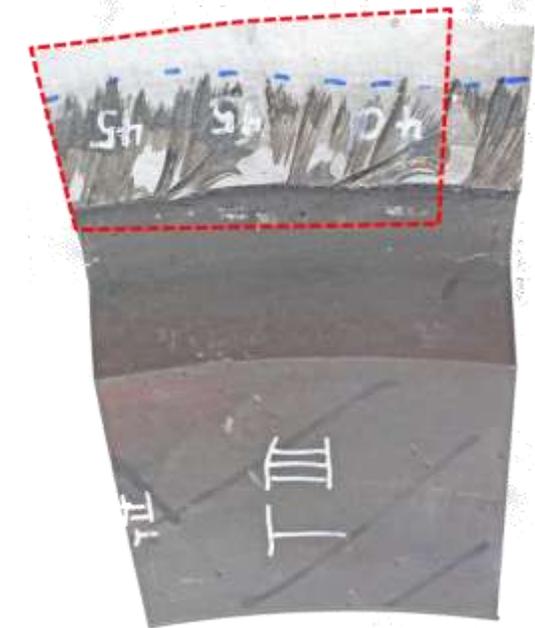
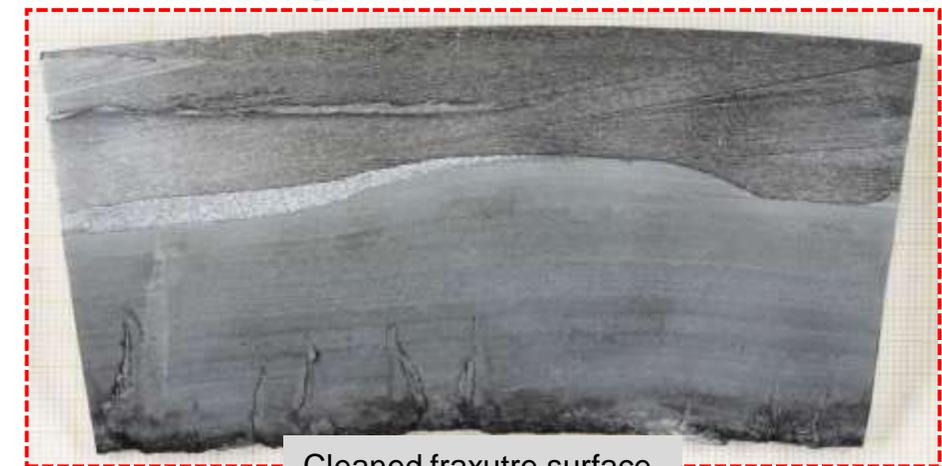
- Macroscopically clear line of crack arrest, → cyclic crack propagation
- Stresses were concentrated in the notch
- Pump was not pre-heated during periods of not operating
- Higher oxygen content present in the water allowed attack

Cleaned fracture surface

- ✓ Several cracks are initiated in the notch
- ✓ Starting points are corrosive/oxidative attack
- ✓ Clear cyclic growth can be detected
- ✓ Clear characteristics of strain induced corrosion cracking

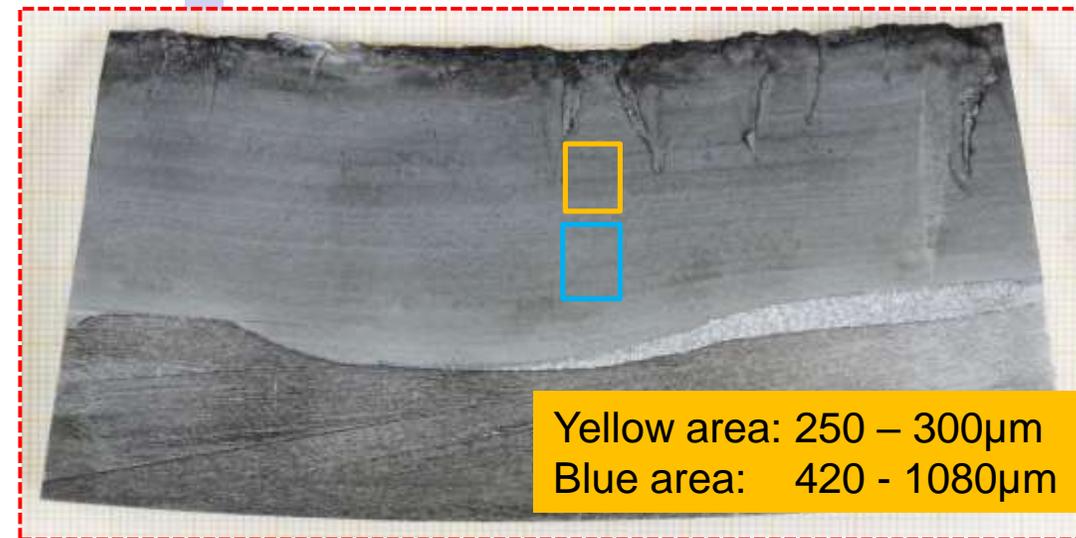
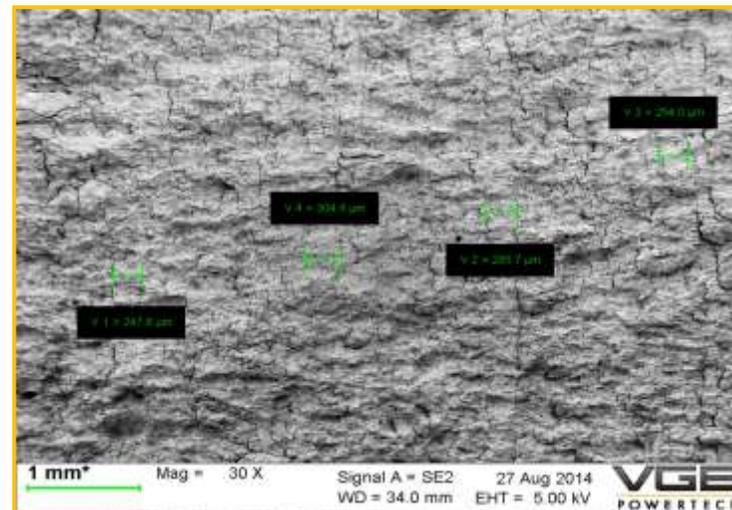
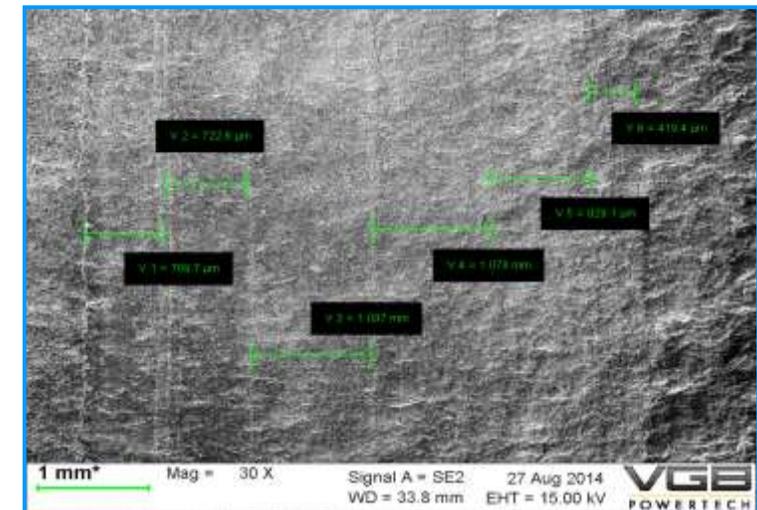
- Crack growth per cycle differs.
- At the beginning crack propagation is less.
- The cycling operation regime of the pump has also an influence.

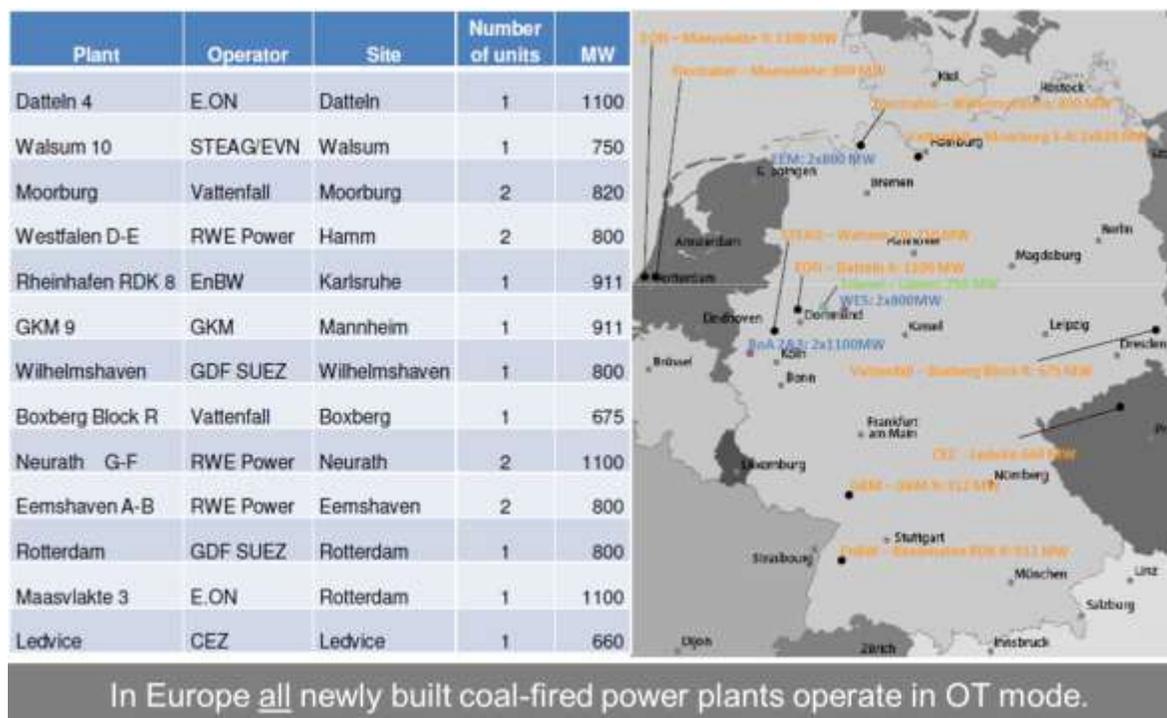
- Due to parameters it is necessary to operate in OT-mode
- Switch to AVT-mode before boiler is stopped
- Re-start boiler with AVT-mode and switch back to OT
- Monitor that boiler is not damaged
